Confidential Inspection Report

December 28, 2009 01:30 PM.

Client:Joe Homebuyer
1245 Happy Ln
Happy Place, WA 98499**Inspection Site:**1524 Sommerset PL
Puget Sound, WA 99999**House Occupied?**

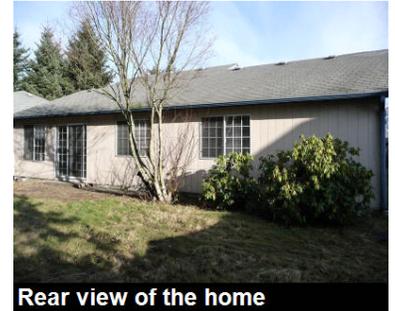
Rear view of the home

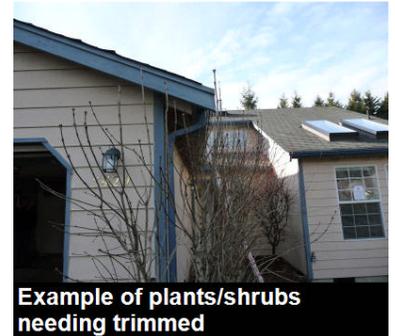
Attention Needed - The shrubs and/or bushes need to be trimmed or maintained. Usually this means that the bushes or shrubs are within 4" of the siding. A 4" gap or air space should be maintained between any plant material and the home to allow for proper air flow and to help remove the moisture. Bushes and shrubs need to be trimmed away from the structure at least 2 inches. This space is needed to prevent direct access to the structure by insects and to keep the bushes from damaging the siding.

Example of plants/shrubs needing trimmed

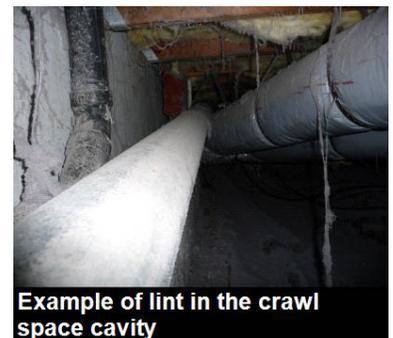
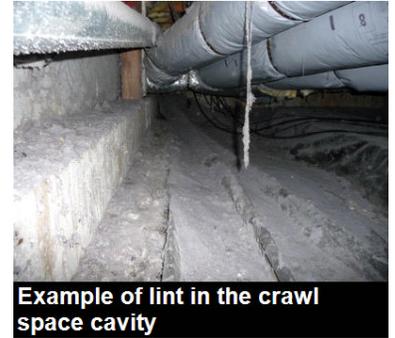
Soil. The crawl space cavity has a substantial amount of lint on top of the vapor barrier and some of the ducts. This was caused by a disconnected dryer vent. Exposed lint is considered a fire hazard and needs to be cleaned from the crawl space area.

Example of lint in the crawl space cavity

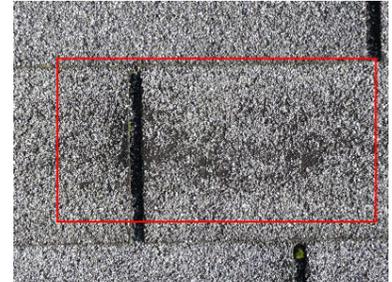
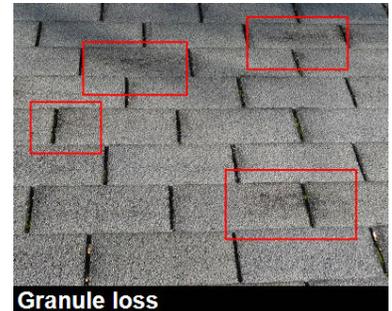
The roof shingles appear to be original to the home. The shingles that are installed are a 20 yr 3-tab design. Some of the shingles have been replaced and there is visible evidence of shingle deterioration (granule loss). Much of the roof has a moss covering which could indicate that the shingles are no longer shedding the water as intended. I recommend that a qualified roofer(s), offer an estimate for replacement.

Granule loss

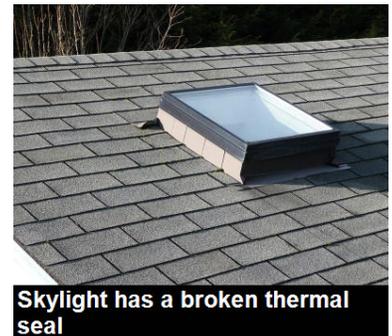
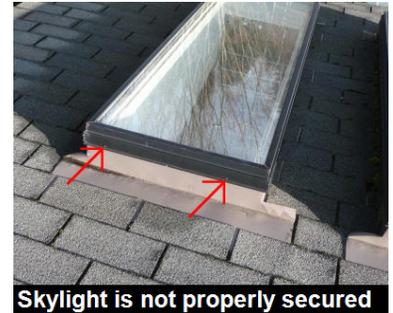
There are 3 skylights installed. All 3 are loose and not properly attached to the skylight curb. The smaller skylight has a broken thermal seal and should be replaced. All 3 skylights need to be properly secured to the skylight curb(s).

Skylight has a broken thermal seal

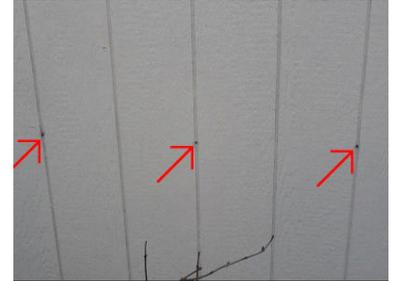
Composite Fiberboard Panels, **Action Necessary** - The LP siding installed on the home is damaged beyond repair and in need of replacement. There is also evidence (drill holes around the exterior of the home into the wall voids) of treatment by a pest control company.

Siding has been treated for insects

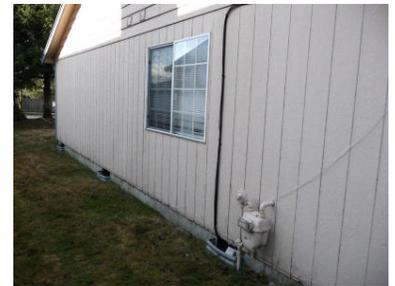
Siding is water damaged

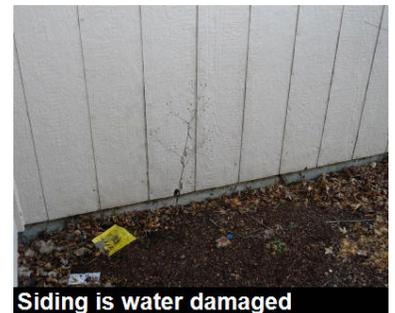
Siding is water damaged

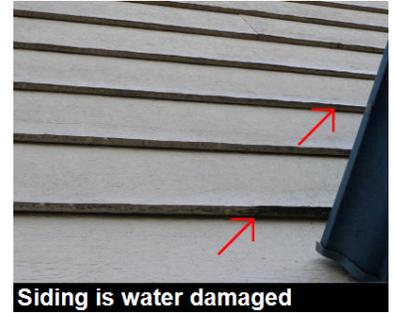
Siding is water damaged

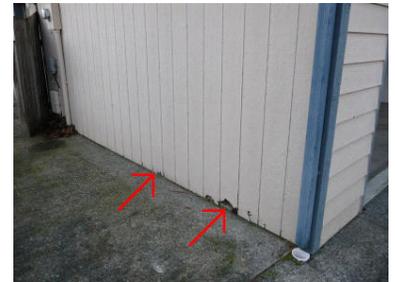
Siding is water damaged

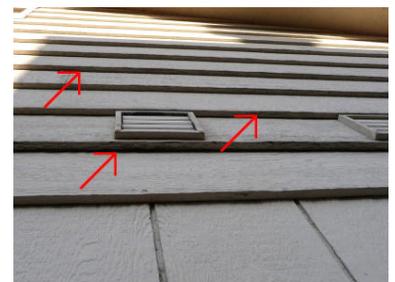
Siding is water damaged/checking

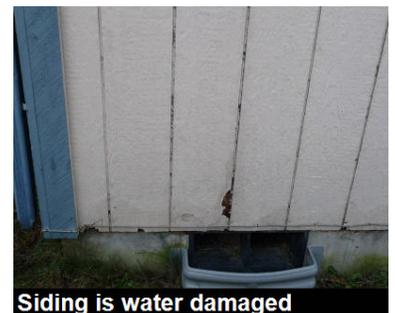
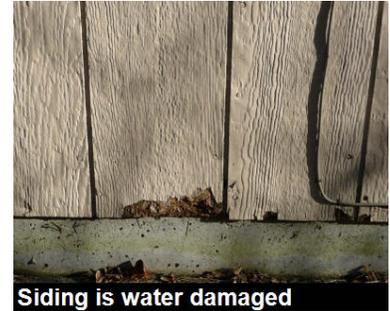
Siding is water damaged

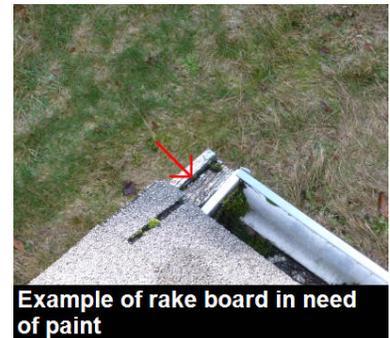
Attention Needed - The fascia and/or rake boards appear to need some minor repair(paint) to prevent further deterioration.

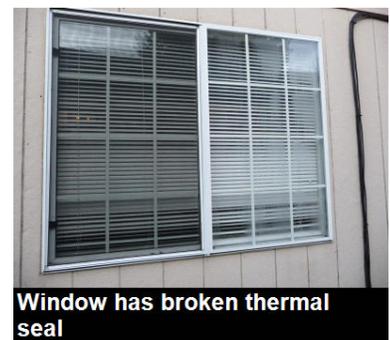
Insulation Seal - One or more insulated glass windows have lost their vacuum seal (bedroom). As a result of losing this seal, condensation between the two panes creates a clouded or streaked appearance. The window still performs the task of keeping the weather out, but it has lost much efficiency.

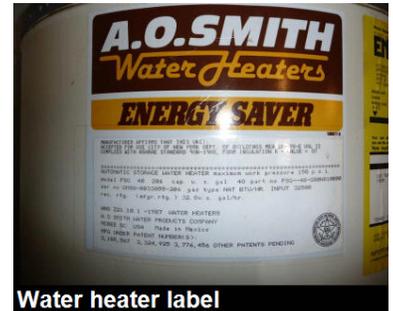
Water heater label

There is an AO Smith gas fired water heater installed in the garage. The water heater is 21 yrs old and well beyond the recommended life span of 8-12 yrs. Replacement is recommended.
